FEAP TR-FM-93/06  
July 1993

**TECHNICAL  
REPORT**

## Demonstration of Polyscann Ultrasonic Butt-Fusion Inspection System for Polyethylene Pipes

by  
**Orange S. Marshall, Jr., and James B. Hunt**  
U.S. Army Construction Engineering Research Laboratories  
Champaign, IL 61826-9005

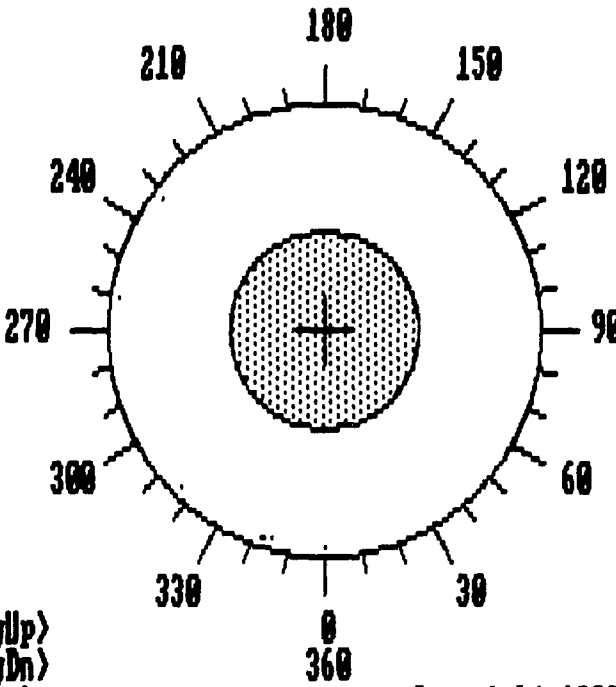
Figure 22. Inspection Report Screen for Weld Made With Excessive Heat.

POLYSCANN INSPECTION REPORT		REV. 2
<p>ECM #: ECM004            INSPECTION #: 000014            PIPE SIZE: 8            INSPECTOR #: 000000011            ECM STATUS:              - FLAWS FOUND -</p> <p>INSPECTOR'S NAME              O. Marshall            INSPECTION DATE              April 1991            LOCATION/JOBNAME              CERL</p> <p>COMMENTS:              Ft. Hood Pipe              Too Hot              Orange Pipe</p> <hr style="width: 100%;"/>

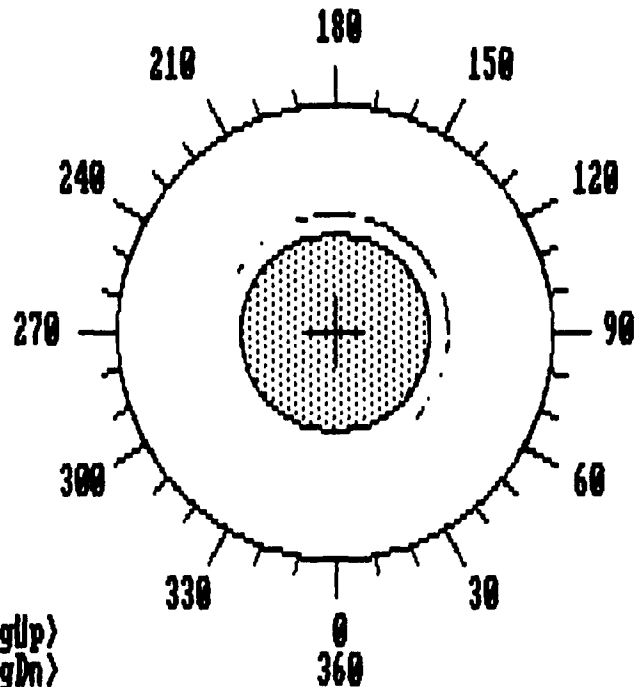
Figure 23. Inspection Report Screen for Weld Made Under Insufficient Pressure.

ECM #: ECM004  
INSPECTION #: 000011  
PIPE SIZE: 8  
INSPECTOR #: 000000011  
ECM STATUS:  
- FLAWS FOUND -

COMMENTS:  
Ft. Hood Pipe  
Not Enough Pressure

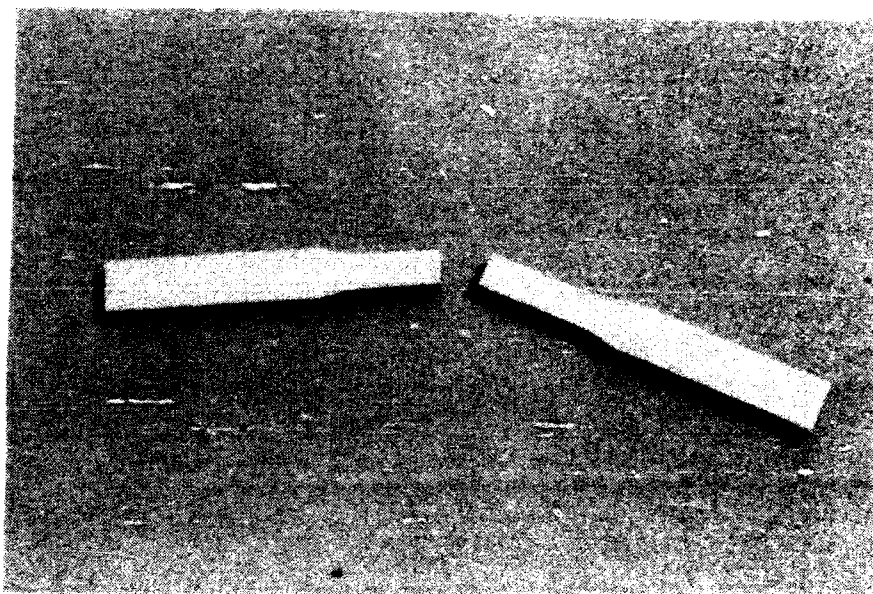
**Figure 29. Example of Non-necking Failure in Joint Specimen.**

necking of the sample to minimize the likelihood of catastrophic pipe failure. Figure 28 shows the normal necking phenomenon for polyethylene. Figure 29 shows a non-necking break at the butt-fusion joint. Pipe samples where both the inside and the outside tensile samples failed were judged as failures. Where only one of the two tensile samples failed, the joint was judged as marginally passing.
